STRESS CORROSION FAILURE OF A LOW PRESSURE DISK FROM A 800 MW STEAM TURBINE

ASIA TURBOMACHINERY & JUMP SYMPOSIUM
SINGAPORE | 22 - 25 FEBRUARY 2011
MARINA BAY SANDS

This case study discusses the root cause analysis of a recent stress corrosion failure of a low pressure disk from a 800 MW steam turbine. Turbine disk modifications to prevent future stress corrosion cracking are detailed.

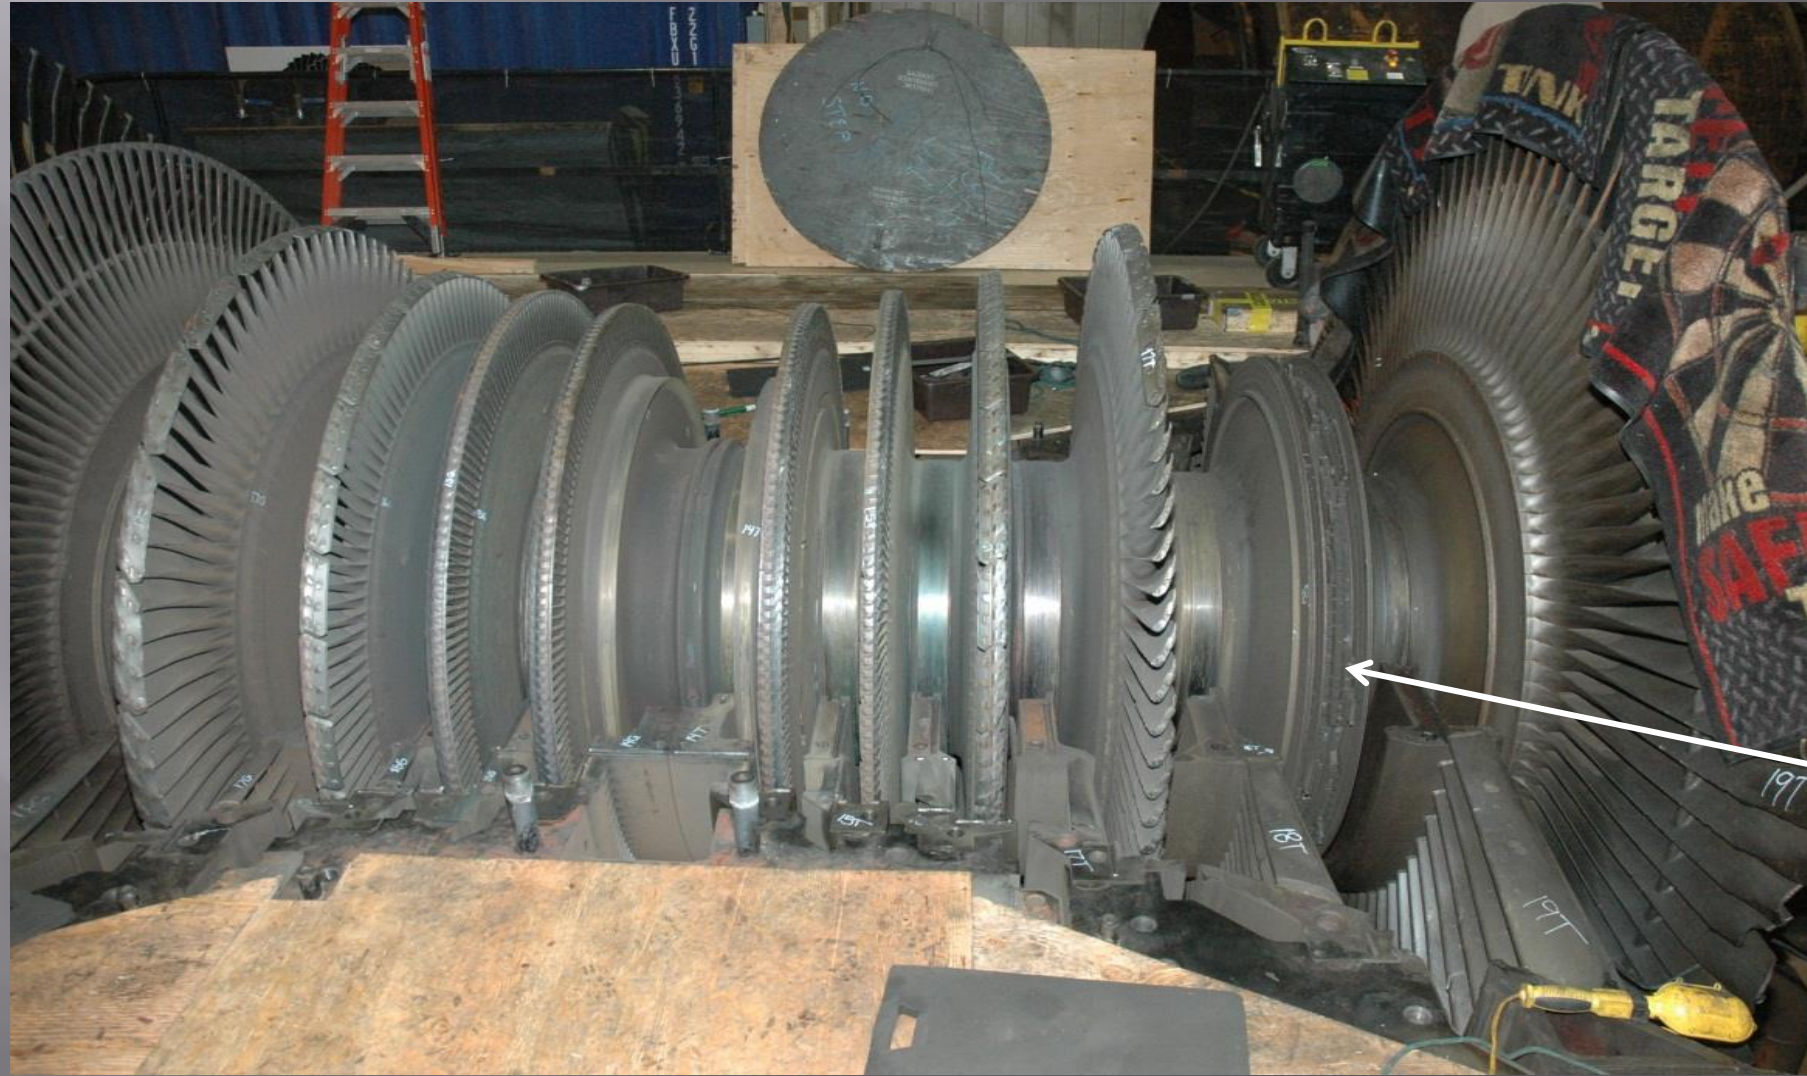
- ▣ One L-1 Low Pressure Turbine Disk had Fractured Circumferentially and Radially through Multiple Finger Pinned Blade Attachments
 - ▣ Approximately 60% of Blades Missing
 - ▣ Imbalance Estimated at 1500 lbs.
- ▣ Remaining Three L-1 Disks Exhibited Stress Corrosion Cracks in Finger Pinned Blade Attachments
- ▣ Significant Internal Damage to all Turbine Modules

Fractured L-1
Disk

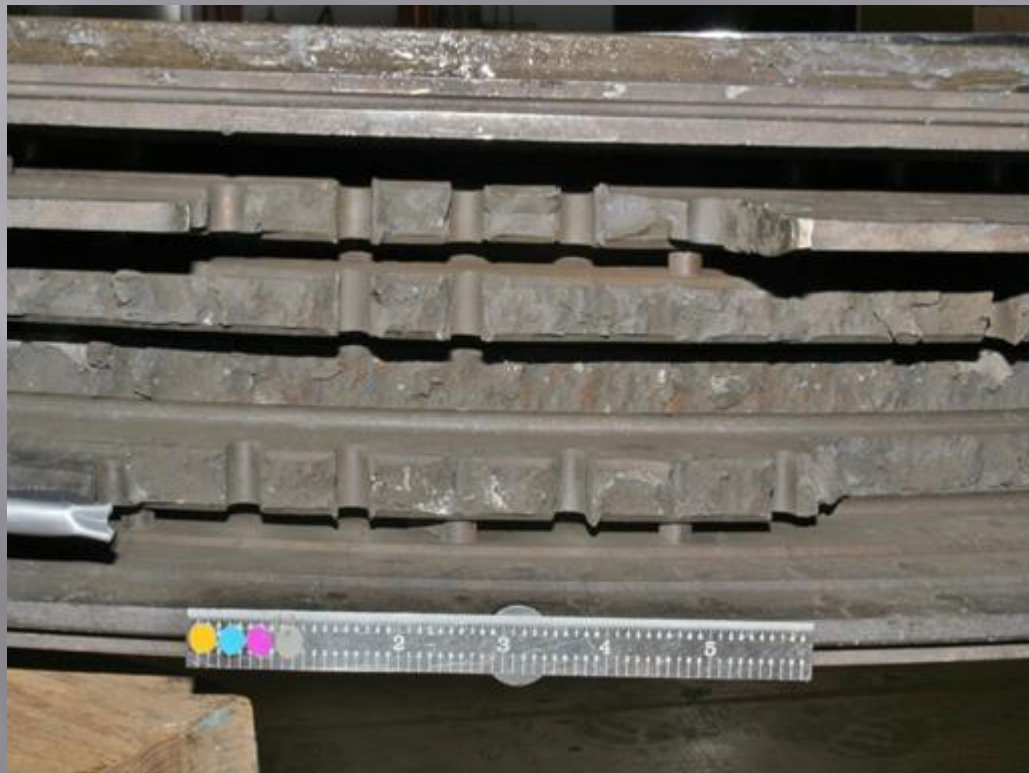
- ▣ L-1 Disk Fractures Due to Caustic Stress Corrosion
 - Initiated at Pin Holes and Finger Ledges
- ▣ Steam Chemistry Within OEM Requirements
- ▣ No Material Anomalies
- ▣ No “Abnormal” Operating Conditions

FRACTURES THROUGH
FINGERS

- ▣ New 12Cr Stainless Steel L-1 Low Pressure Turbine Disks Installed
- ▣ Disk/ Blade Geometry Modified
 - Reduce Stress Concentrations
- ▣ Finger Pinned Root Attachments Shot Peened after Final Machining

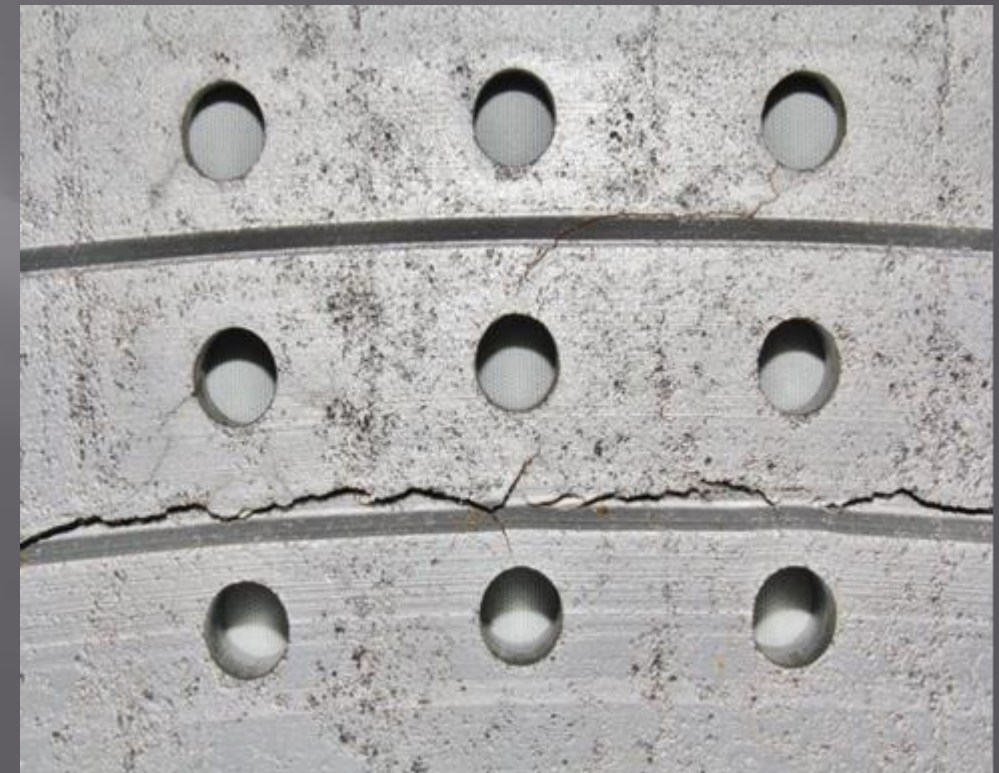
SCC CRACKS AT LEDGES AND
PIN HOLES

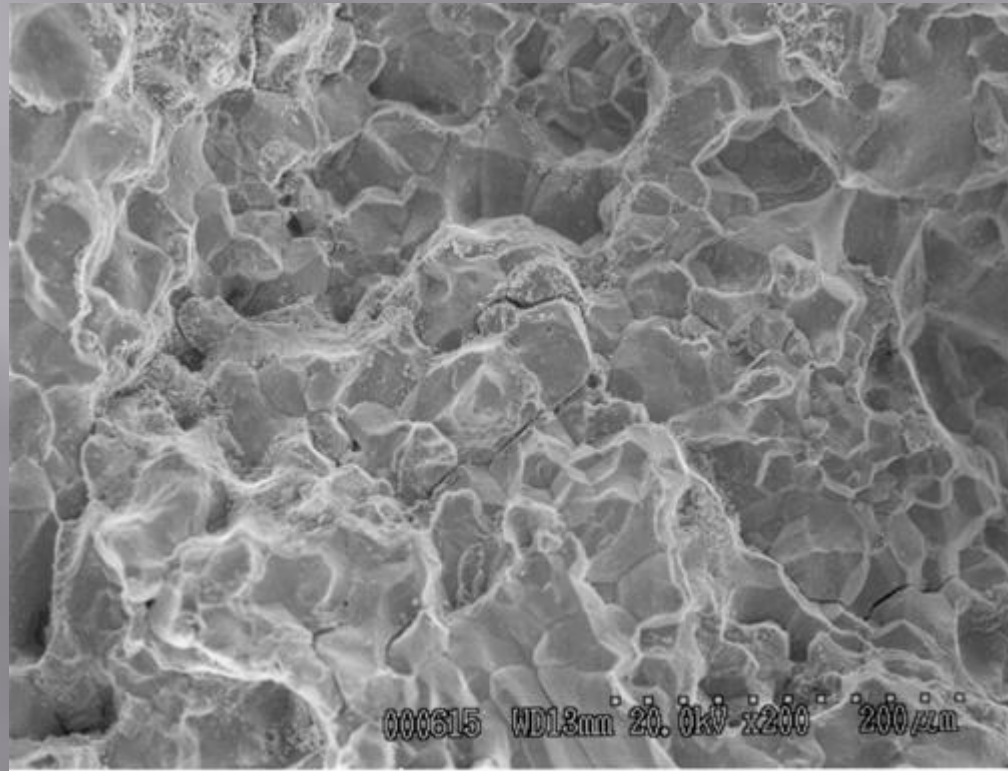
INTERGRANULAR FRACTURE

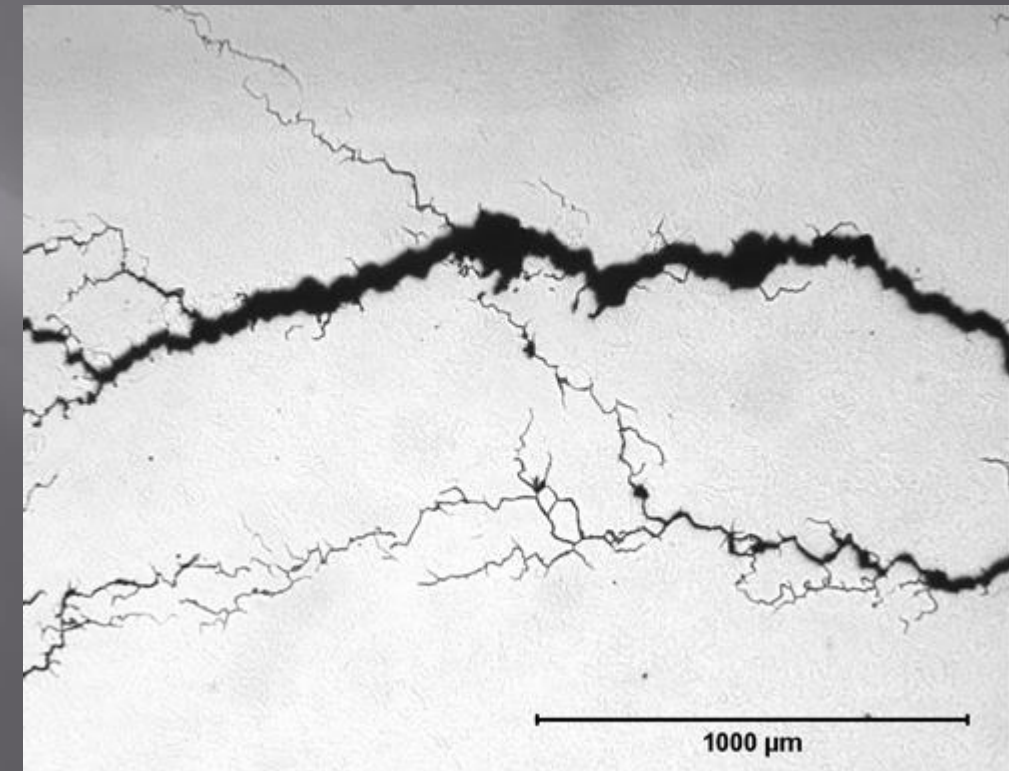
CRACK BRANCHING

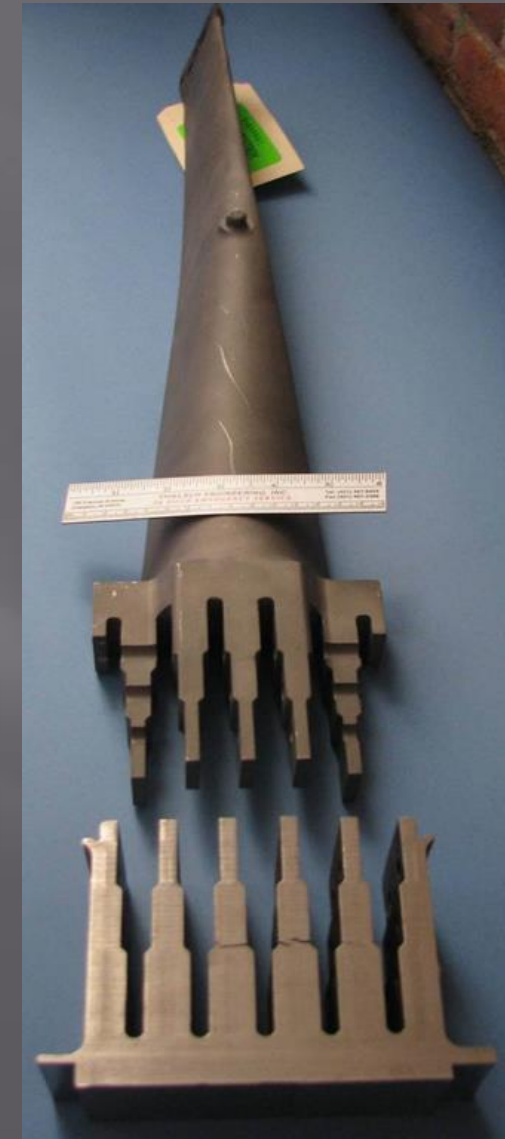
- ▣ Blade Attachment Design Requires Blade Removal for Non-Destructive Examination of Disk Fingers
 - Limit on Number of Times Blades may be Removed
